**THE STATE OF OTTOMAN ARCHITECTURE IN MACEDONIA
AND LATEST RESEARCH***

*Selçuk SEÇKİN***

In this paper, we will discuss our project, entitled as “Ottoman Monuments in Macedonia”, supported by Scientific Research Projects of MSGSU. This field work Project we undertook in the months of July and September 2014. Many structures were identified as a result of field work. We have gathered many data in this field work that will be presented with an assessment over all. In this context, we will study Ottoman Monuments previously listed as an inventory work by the Macedonian State Ministry of Culture in 1991. In this Project we verified the list of Ottoman structures in Macedonia taken from the Macedonian State Ministry of Culture. Also we found recently identified Ottoman structures which are not in this list. Also the structures in this list which are in existent or repairs performed will be discussed. Emergency repairs, maintenances and their latest state of the structures will be examined. Ottoman monuments that still preserve the original characteristics of these structures will be highlighted. Ottoman structures that we have identified will be informed with their overall architectu

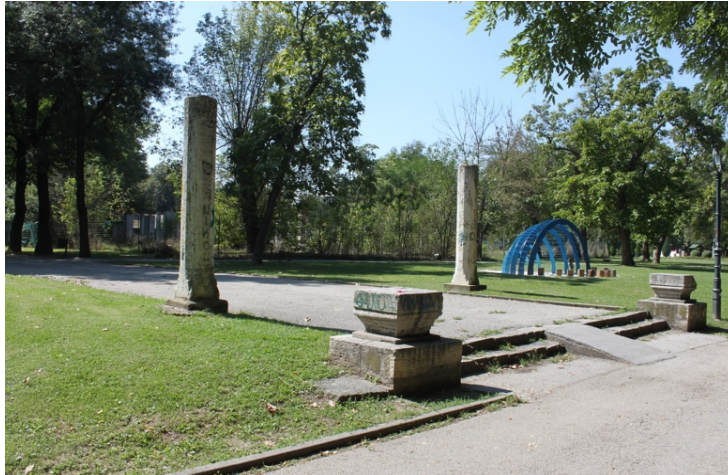
One of the memorable but no longer extant buildings of Ottoman Skopje was the Burmalı Mosque (Eyice, 1963, p. 22; Ayverdi, 1957, p. 1-57). which was built by Karli İli Mehmet Bey. It was demolished in 1925 to build a military guest house. According to its inscription panel, which was close to the Taş (Stone) Bridge on the Vardar River, the mosque was constructed in 1495. Distinct with its roof and minaret, the remains of this mosque are in the Islahhane Park today. Other than this building, there are other mosques that are no longer extant –Fatıhi Paşa Yiğit Bey, İbni Payko, Faik Paşa, Muradiye, Yelen Kapan to name a few. One of the earliest surviving monuments is the Sultan Murad Mosque built in 1436, which was part of a *külliye*. The mosque forms an ensemble with a madrasa, school, two *türbes* and a clock tower. The building was constructed on a high hill and was enclosed within a wall. It was repeatedly repaired following fires, and finally after the 1963 earthquake, however, the deep cracks in its walls and damaged timberwork need urgent repair (Photo 1; İbrahimi, 1989, p. 39).

Photo 1: The relics of Burmalı Mosque in Islahane Park

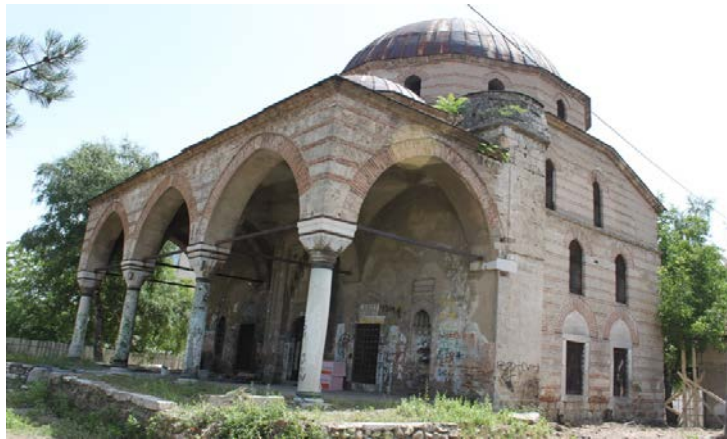
Haydar Kadı Mosque is one of three large-scale mosques in the town centre and its inscription panel states that it was built in 1561-2 (Photo 2). The double-minaret mosque has a square-plan that transitions into a drum through squinches. The building was damaged during the Ottoman retreat from Monastir in 1912 and its minaret collapsed as a result of artillery fire. It is being restored by the General Directorate of Foundations. Another large mosque is the Ishak Çelebi Mosque. According to its inscription panel, the building was restored in 1506-07. It was restored in 2016 by TİKA and is open for worshippers. Opposite the clock tower in the town centre of Monastir, there is the 16th century Kadı Mahmut Efendi (Yeni) Mosque. (Photo 3) It was under threat during the 2001 civil war. The building was not transferred to the Macedonian Muslim Authority on grounds that the lower levels of the building, exposed during excavations conducted in the vicinity

Photo 2: Haydar Kadı Mosque

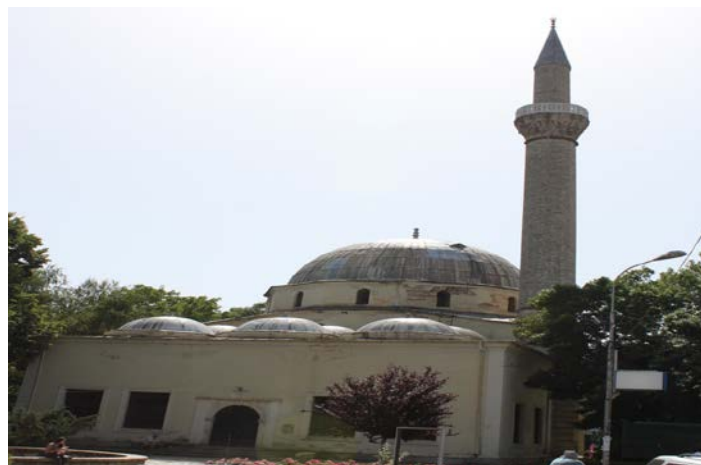
Photo 3: Manastır New (Yeni) Mosque

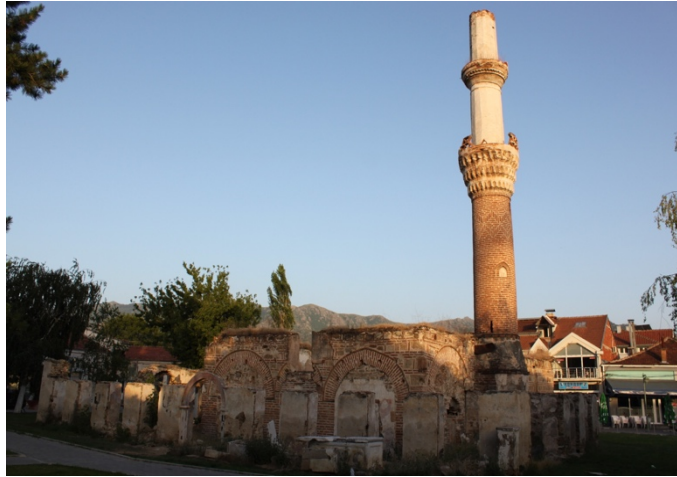
There were three known mosques in Prilep. The Orta Mosque was demolished during new development work while the Çarşı (Market) Mosque was burned down during the Civil War –although listed, it remains a ruin and is used as a dump. The other mosque, han and hamam are in ruins. The clock tower preserves its original form (İbrahimgil, 2002, p. 1173-1181; Photo 4).

Photo 4: Prilep Market (Çarşı) Mosque

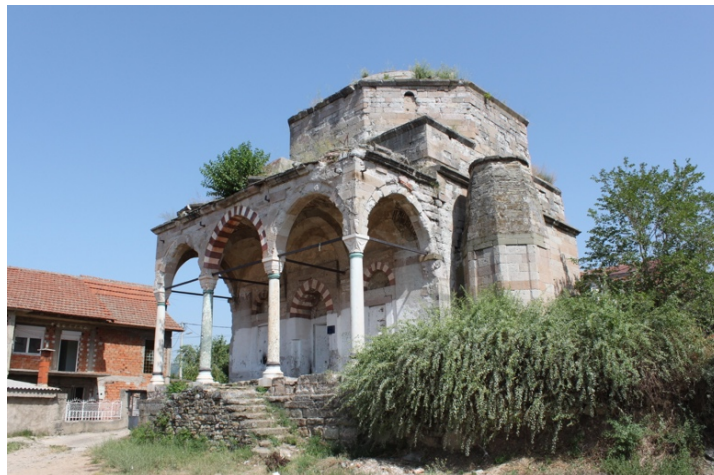
Another important settlement is Stip. There is a 16th century mosque (Hüsamettin Paşa Mosque) on the prominent hill overlooking the town. (Photo 5) There were plans to convert this mosque into a church but this move was prevented by the Muslim community. Although the building is in a dangerous state due to large cracks in its walls, political tensions concerning the use of religious buildings prevent its restoration. There is also a large bedesten, Kadın Ana Mosque, Radovis Tekkes, and a clock tower in this town.

Photo 5: Stip Hüsamettin Pasha Mosque

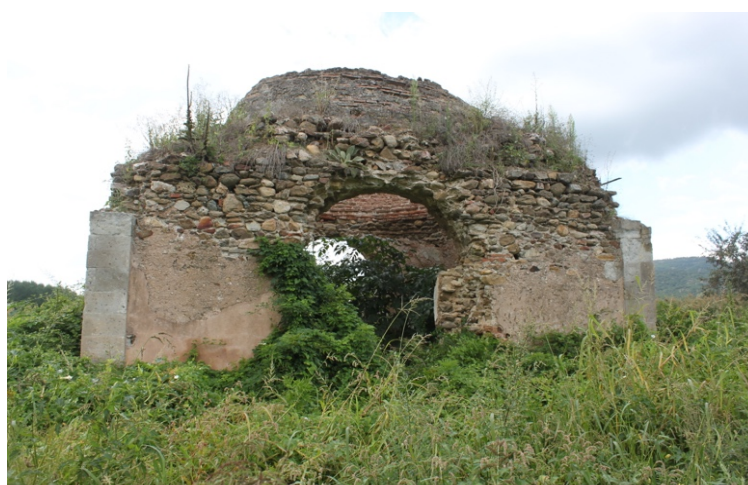
In Köprülü (known today as Veles), there are only the Fazil Ahmet Paşa Mosque (victim of an arson attack in 1994) and the clock tower. In the center of Konche, a small settlement, other than a mosque there is a türbe on the outskirts of the town in an agricultural field. It belongs to Pranko Lazarat, the father of Evrenos Bey. Its vicinity was once a stopping point with accommodation but today only the guard house (*karakol*) and the türbe remain (Kılıç, 2012, p. 87-99; Photo 6).

Photo 6: Pranko Lazarat Tomb (Türbe)

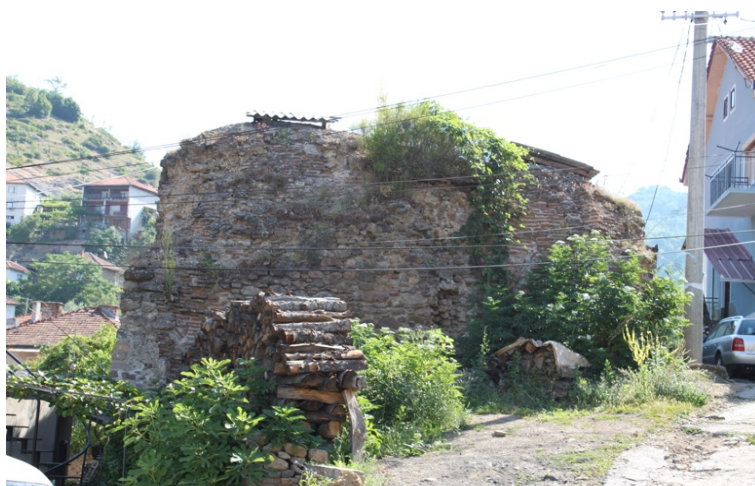
Fotoğraf 8: Turkish Bath Relic in Kratovo

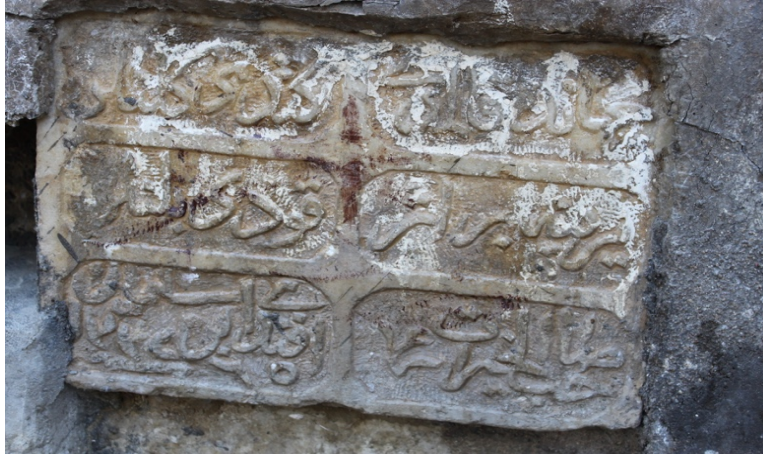
Fotoğraf 10: Inscription of Gabrovo Mosque

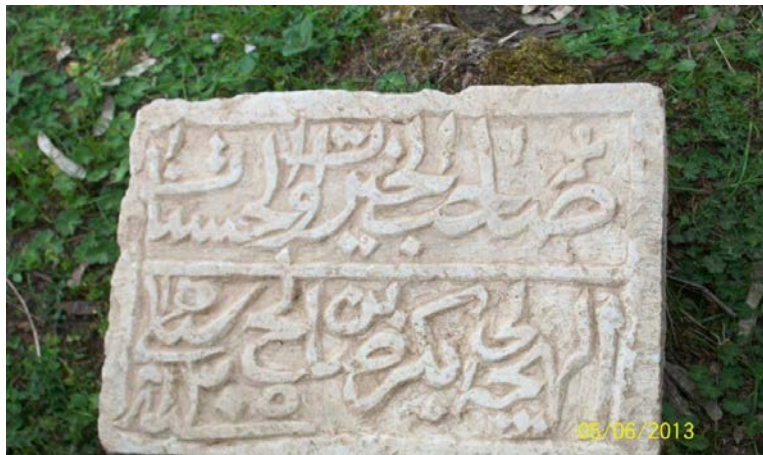
Photo 11: Inscription of Eġla Mosque

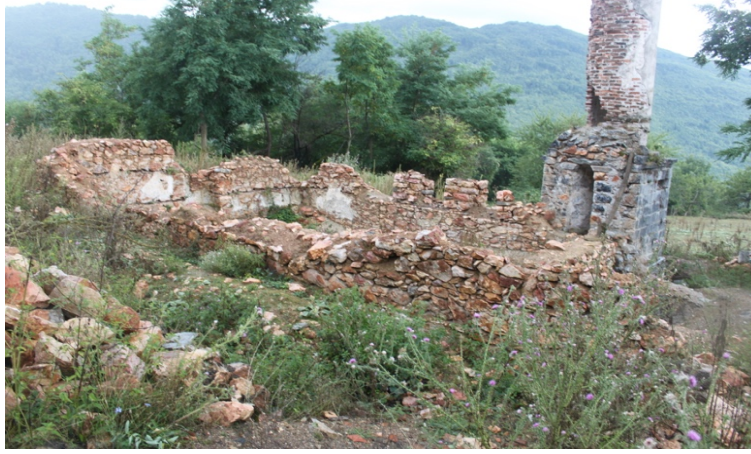
Presil and Sazdevo villages, and in the villages of Bacista and Stromista in Zajac, the mosques have been fully renewed (Photo 11; Photo 12).

Photo 12: Relic of Eğla Mosque
